**NASA TM X-53807**

**COMPATIBILITY OF METALS WITH HYDROGEN**

By C. E. Cataldo  
Propulsion and Vehicle Engineering Laboratory

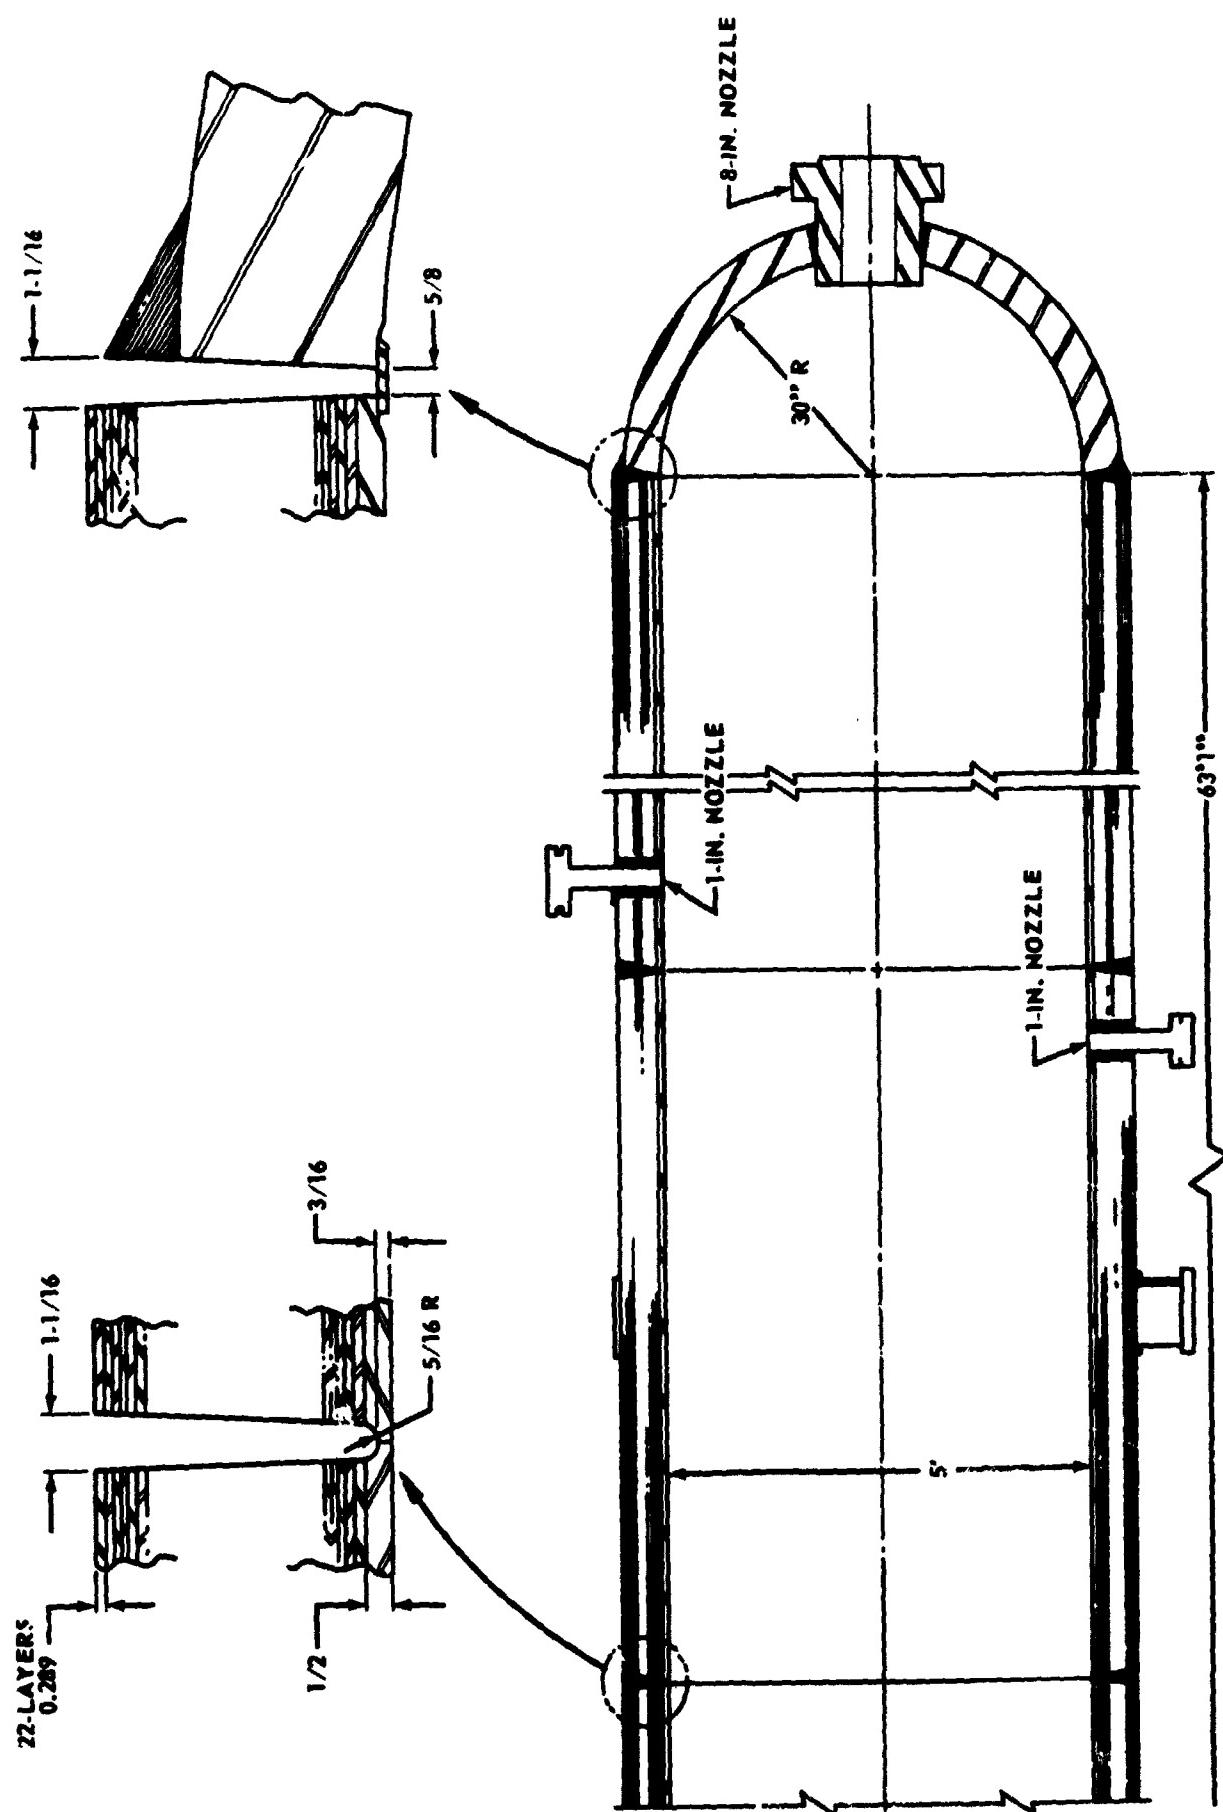
FIGURE 1. Sketch of Multiple Layer Construction for Pressure Vessel

These early failures occurred in vessels with laminated cylindrical sections, some with up to 22 layers, 0.289 inch thick, made with type 1146a steel and solid, forged heads of A225-B steel. A sketch of such a vessel is shown in Figure 1. The leaks were in the circular weldments where the 1-inch nozzles were inserted. A stress analysis indicated that the normal working stress plus the anticipated residual stresses may have been sufficient to result in failure. Also, fatigue due to the many pressure cycles used, could have contributed to failure in this area. However, since similar vessels of this design were known to have experienced long and satisfactory service histories with gaseous nitrogen, at 5000-8000 psi, the hydrogen pressurant was suspected as being the factor which contributed most to the leakage. In those particular vessels, however, the welded ports were replaced with a mechanical closure. One of the 1146a vessels was replaced in the hydrogen system with a vessel made of A517-F (T-1) steel. This fully stress relieved vessel was intended for use at 5000 psi; after ten pressure cycles, the vessel failed with an audible crack, although not catastrophically.

Leakage through the innermost shell egressed through weep holes drilled into each of the covering layers. Subsequent disassembly of this vessel revealed a considerable number of surface cracks in the welds of the shells. Two other T-1 steel vessels, which had not been in hydrogen service, were inspected and cracks were discovered in both of these also, although the cracks were not through the thickness of the shell. Thus, again, the matter of the influence of hydrogen was questioned.

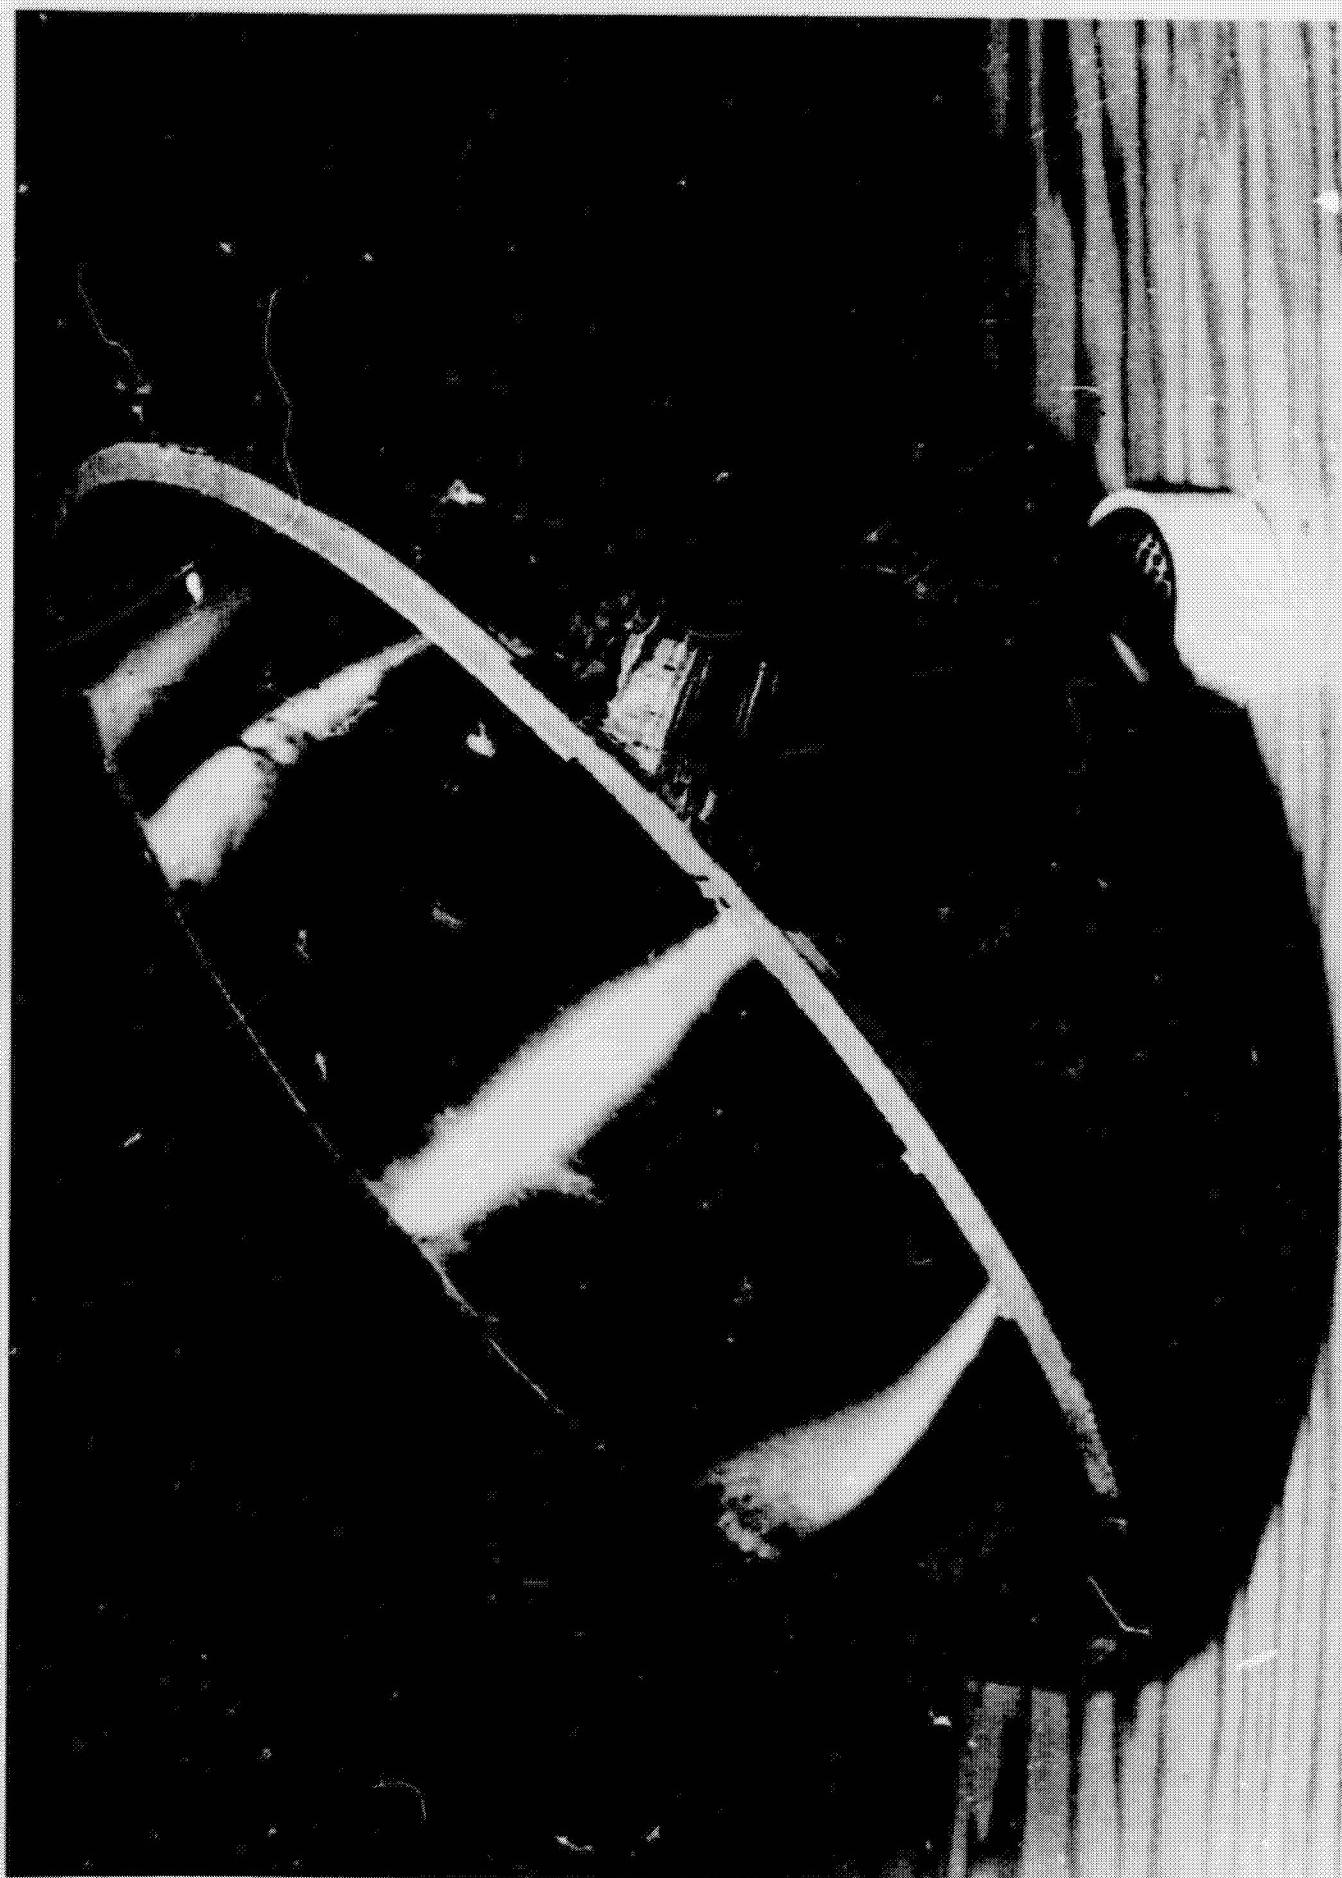
FIGURE 2. - Half-Sphere of fractured tinted Methacrylate Bottle  
or 1017  
3/2, 66

In late 1966, during a preflight test of a Saturn launch vehicle third stage, an explosion occurred which completely destroyed the stage. Ultimately the explosion was traced to a Ti-6Al-4V helium pressure bottle which ruptured prematurely, causing secondary rupture of the stage propellant tanks.

An extensive metallurgical examination of the remains of this particular titanium bottle disclosed that (1) the bottle was welded with commercially pure (CP) filler wire rather than the specified Ti-6Al-4V filler, (2) the welds contained considerable amounts of titanium hydride phases, and (3) these hydride phases had diffused and segregated at the CP metal--parent metal interface and resulted in a relatively wide and extremely brittle zone. Subsequently, an extensive investigation was undertaken to determine why such quantities of hydrides formed in this case. Although CP wire was used mistakenly by the fabricator of these particular vessels, it is generally accepted as a suitable filler for Ti-6Al-4V alloy, and no previous problems had been reported with actual hardware. It was found that the thickness of the weldments in this bottle was such that multiple (seven to ten) weld passes were required and, consequently, little dilution of the filler and the parent metal occurred. This difference in composition, the tendency for hydrogen absorption in alpha titanium to be different than that for beta titanium, and the stress relief treatment used subsequent to welding appeared to satisfy the correct combination of factors to cause the formation of hydrides in the fusion zone. Figure 2 shows a half sphere of the bottle which failed and the complete fracture in the weld interface. Figure 3 is a cross-section view of the fracture and micrograph of the interface area showing the band of titanium hydride in a small section of the joint which did not rupture.

Since this particular pressure bottle had passed a proof test previously at a higher pressure than the final burst pressure, it became apparent that the hydride formation was not stable and had a deteriorating effect with respect to time, temperature, and applied or residual stress. As a result of laboratory evaluations made in connection with this investigation, a number of other observations were made as follows:

b. Manufacturing processes are more carefully controlled to assure that commercially pure filler wire is not used for thick titanium weldments and that good alloying is effected between the filler and the base metal in thinner materials.

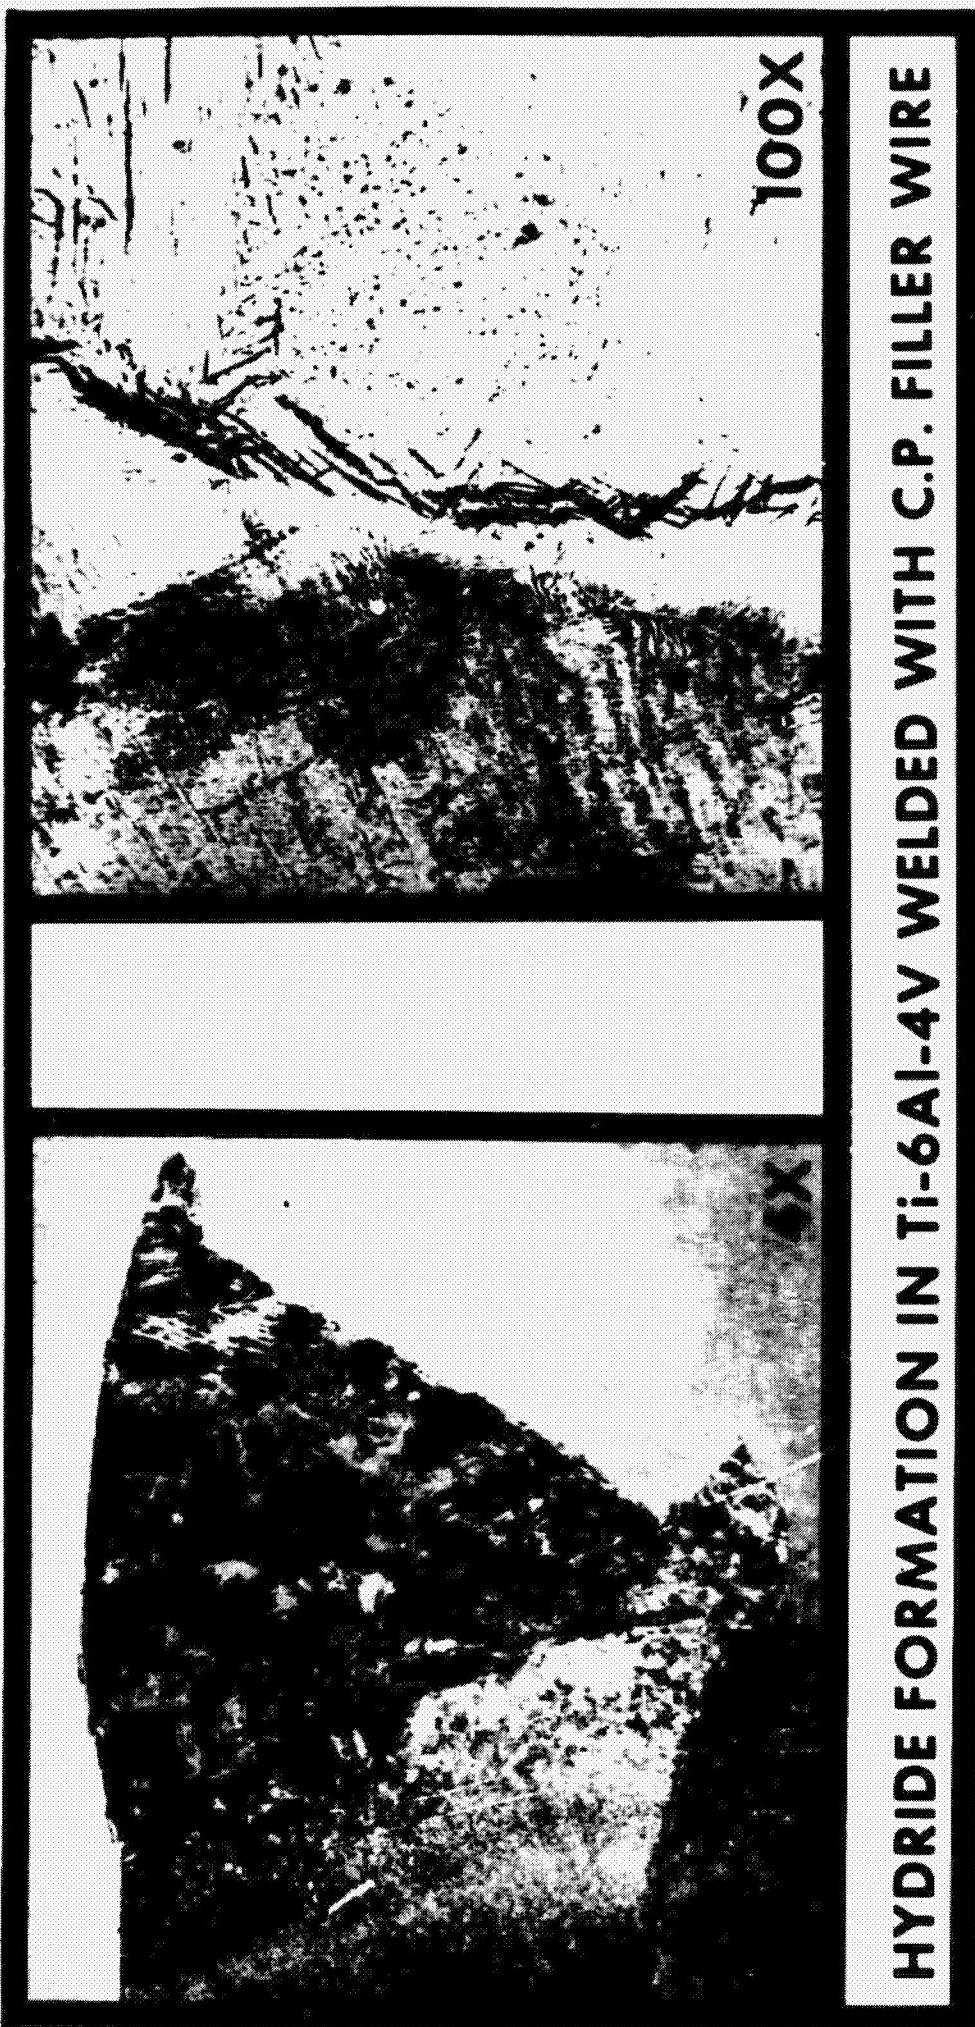
FIGURE 3

1. Hydrides are generally not apparent in the as-welded condition when Ti-6Al-4V is welded with CP wire. Small isolated precipitates may be located, but not in significant amounts.
2. Hydrides in various amounts generally always result from 1000°F stress relief treatments for 1 to 2-1/2 hours; small precipitates will tend to grow during the heat treatment.

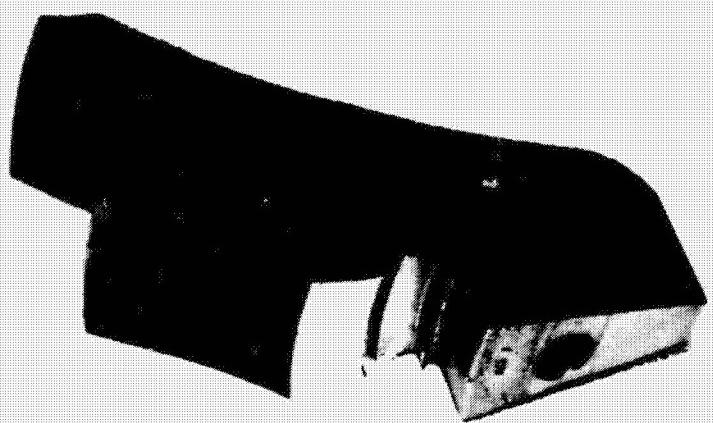
FIGURE 4

Cross-Section of Threaded Segment of Pressure Bottle

Cross-Section of Threaded Area
